Monitoring of Progress After Total Hip Replacement in Dogs Using Walkway™

by Mila Friere-Gonzalez, DVM & B. Duncan X. Lascelles, PhD

This case report describes sequential assessment of hind limb use in a case of bilateral total hip replacement in a dog, and demonstrates how Tekscan's Walkway™ allowed for objective evaluation of changing limb use as the total hip replacements were performed.

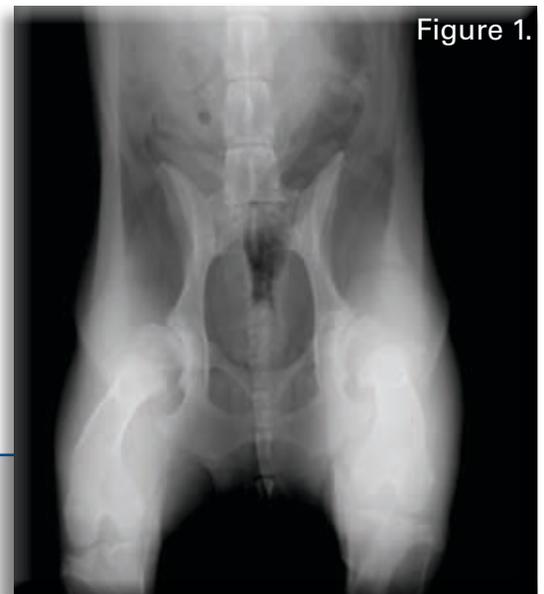
Figure 1 (right). Ventro-dorsal radiograph of coxofemoral joints at initial visit. Note the lack of extension of both hind limbs that was possible.

Overall Assessment: Bilateral hip dysplasia with severe DJD (Figure 1) and significant pain, as a consequence.

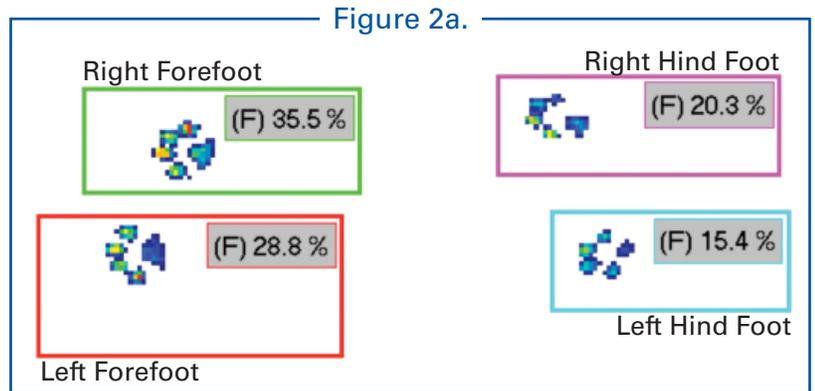
Figure 2a: Representative bodyweight distribution profile showing decreased use of both hind limbs, but particularly the left. In this profile (and all others shown), the dog is facing the left, and the limb positions are as labeled at right.

Using the *Walkway*, it was determined the left limb was most impaired (Figure 2). We have found that static parameters are very sensitive indicators of limb use, and are a straightforward way to quickly collect useful data in the clinic environment.

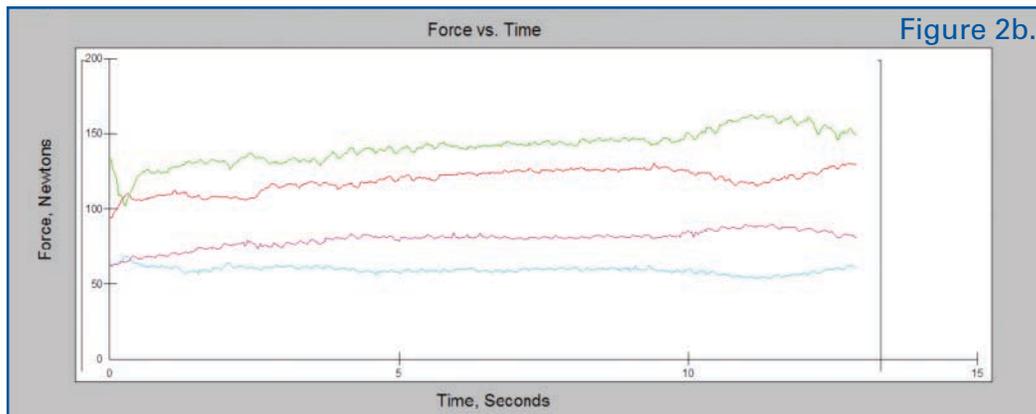
Figure 2b: The graph is used to determine what part of the 13 seconds of data recording will be used for data analysis. In this case, steady standing can be seen to occur between 4 and 9 seconds. This 5-second-long segment is used for data calculations.

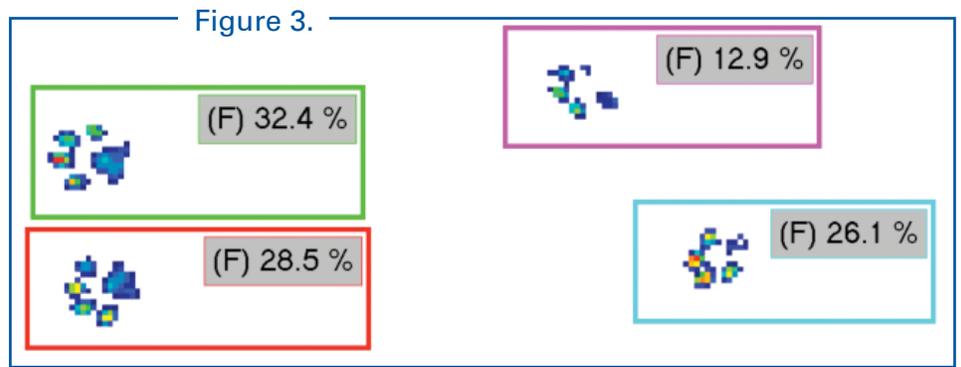
Figure 3: Representative bodyweight distribution profile showing good use of the left hind limb 3 months following THR.

At 3 months, the owners reported the dog was doing well on the left hip. Static evaluation on the Tekscan force pad confirmed increased weight bearing on the operated limb (Figure 3).

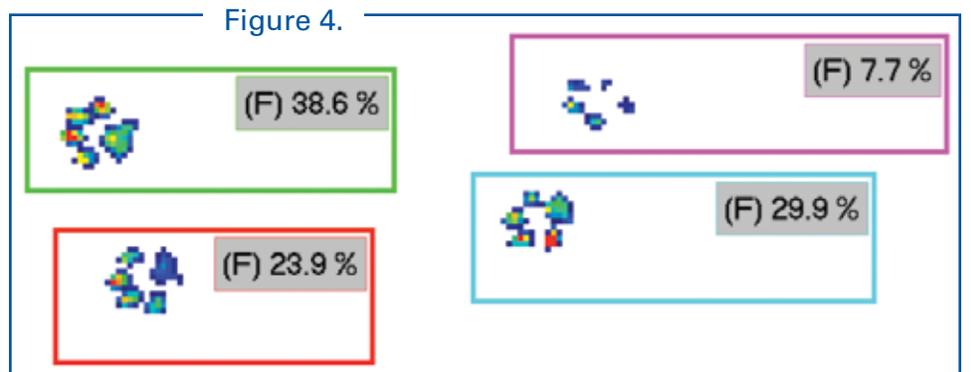
Figure 4: Representative bodyweight distribution profile at 10 months following left THR, and just prior to performing right THR.

Tekscan Pressure sensitive walkway was used to evaluate limb use, and confirmed limited use of right hind limb (Figure 4).

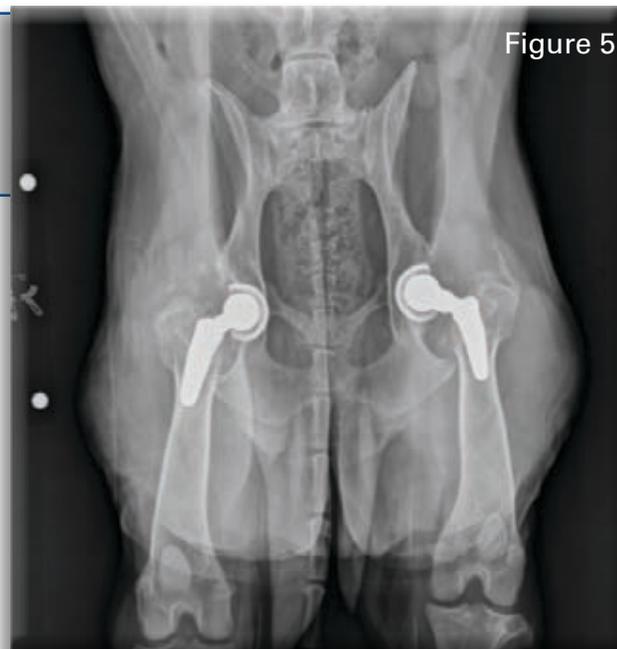
Figure 5.

Figure 5: VD radiograph of the coxofemoral joints showing good placement of both BFXTHRs, and no radiographically apparent implant related problems.

Orthopedic exam: The dog was found to be in excellent condition with no obvious lameness. Mild muscle atrophy was present in the right hind limb (to be expected at that stage following THR surgery). Radiographic evaluation confirmed that there were no problems with the prostheses (Figure 5).

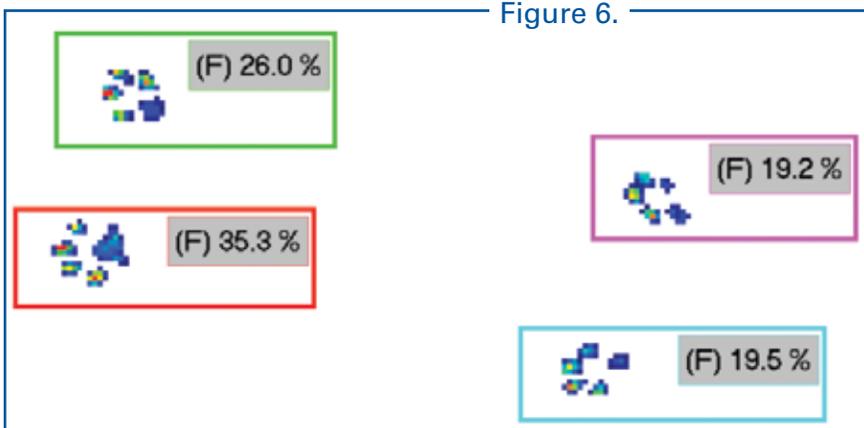
Figure 6.

Tekscan evaluation was performed, and equal normal standing weight-bearing¹ was found for both hind limbs (Figure 6).
